Structural Stability of Stimson Cooling Pond Embankment Preliminary Engineering Analysis

Prepared for: Dept of Justice

Prepared by: Dept. of Natural Resources and Conservation

January 2006

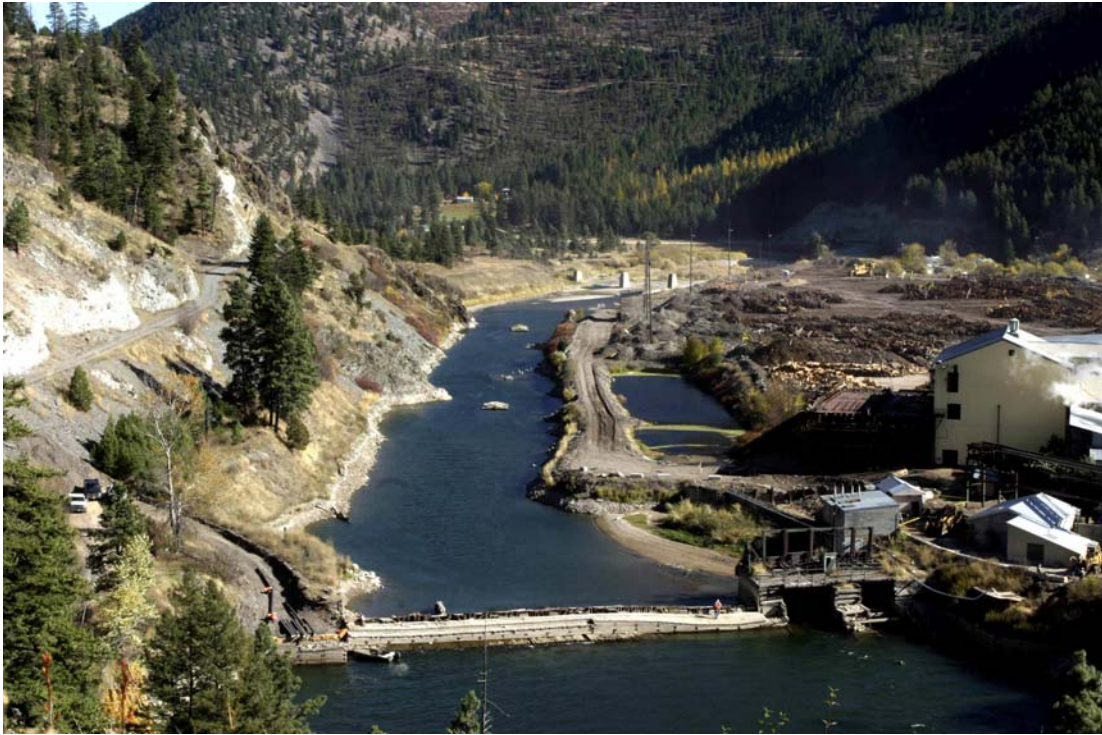
Figure 1: View of Stimson Dam, pre-dam removal (November, 2005)

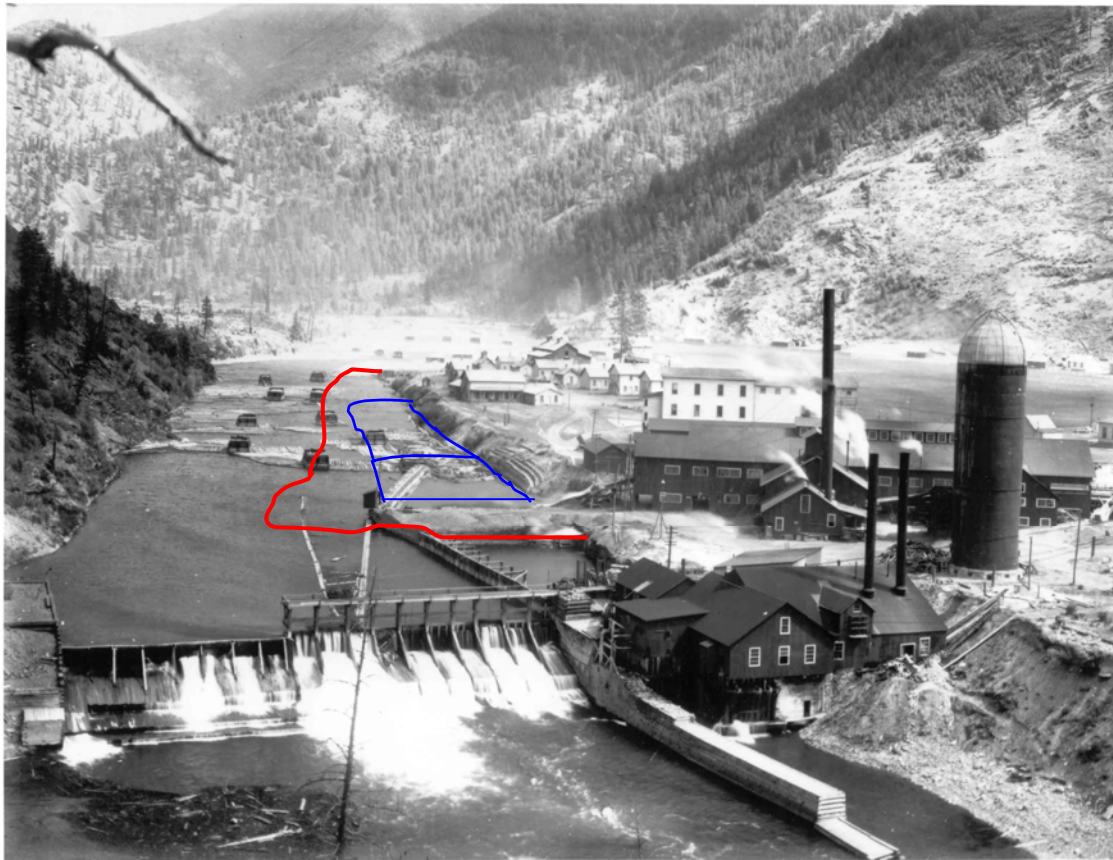
Figure 2: Stimson dam, 1900's with cooling pond embankment projected

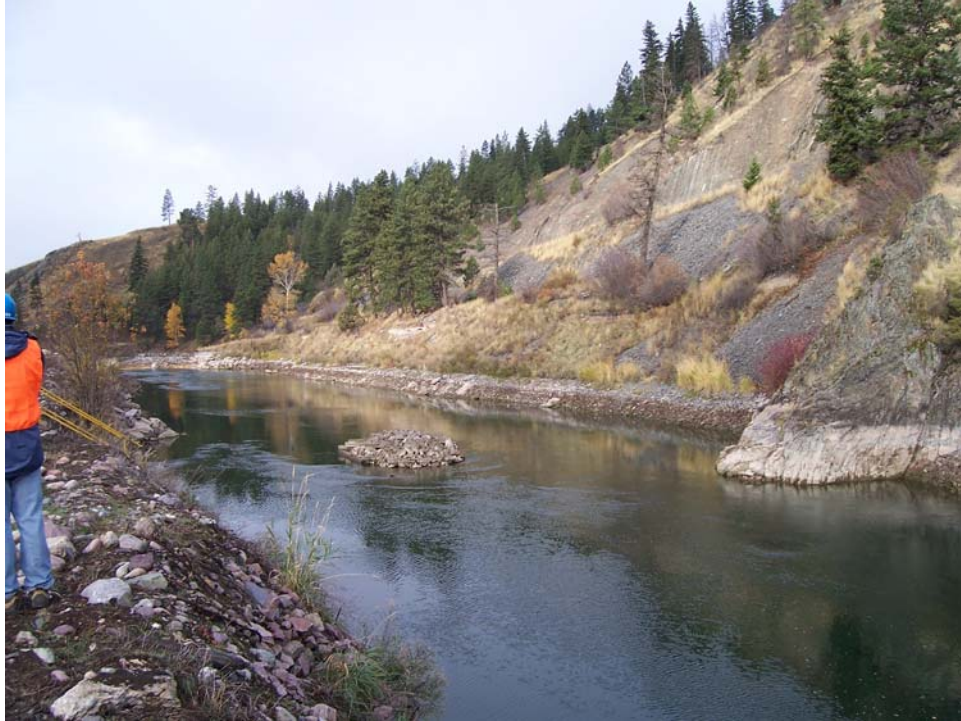
Figure 3: Mid River Crib Structure – Similar crib structures as shown in Figure 1 & 2 were believed to be used as base structures for cooling pond embankment

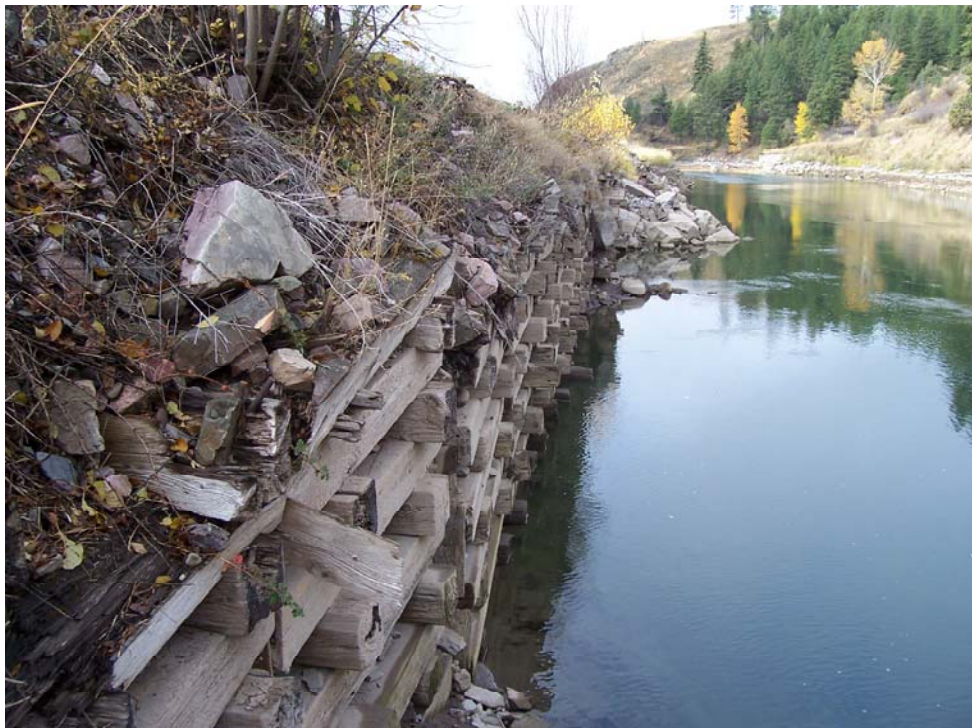
Figure 4: Embankment Crib structure. It appears that the old mid river cribs shown in Figure 1 were filled in with soil and rock and a new timber crib structure built on top.

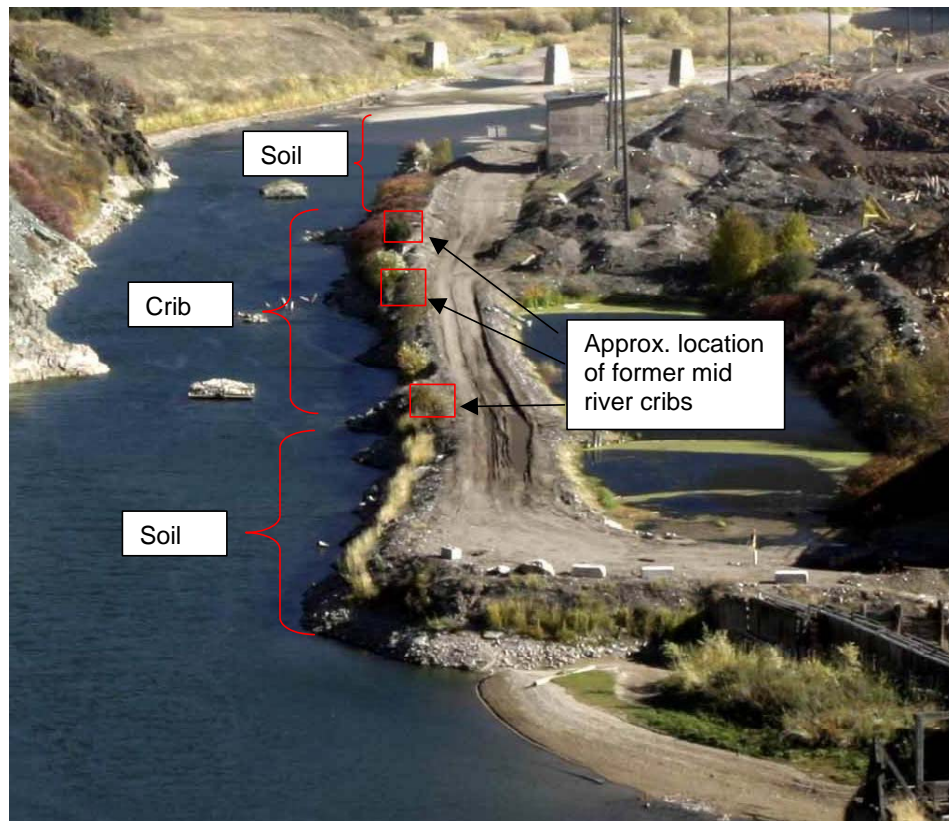
A visual analysis of the embankment conducted in October 2005 supports this conclusion, as shown in Figure 5.

Figure 5: Suggested embankment construction superimposed on photo of cooling pond embankment

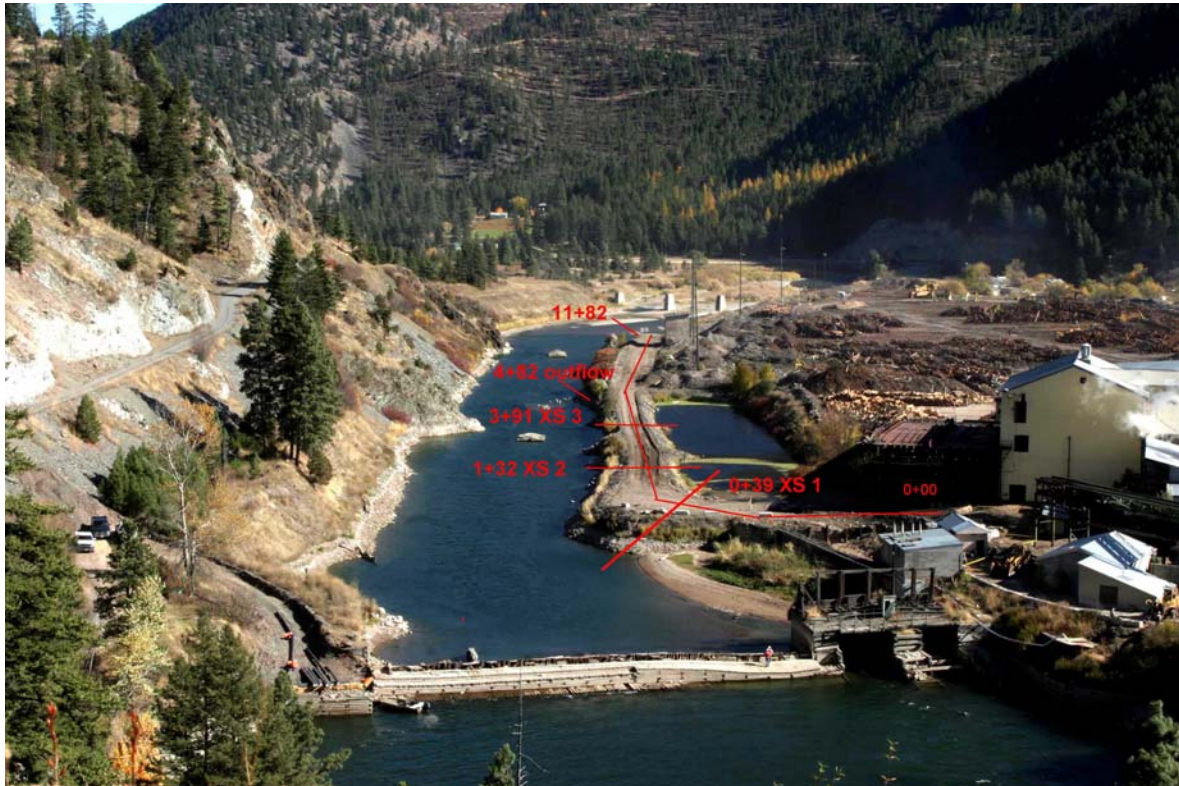
Figure 6 Stationing and location of embankment cross-sections that were evaluated. The embankment is believed to primarily soil in cross sections 1 & 2. Cross Section 3 is primarily timber crib.

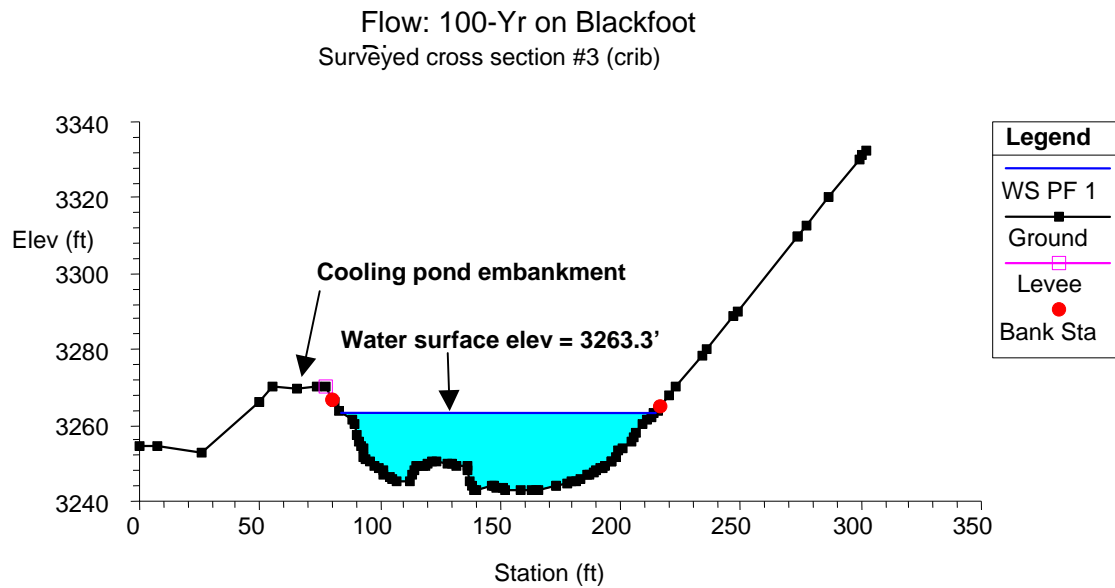
Figure 7. With Milltown dam removed, the water surface of the Blackfoot River does not overtop the embankment.

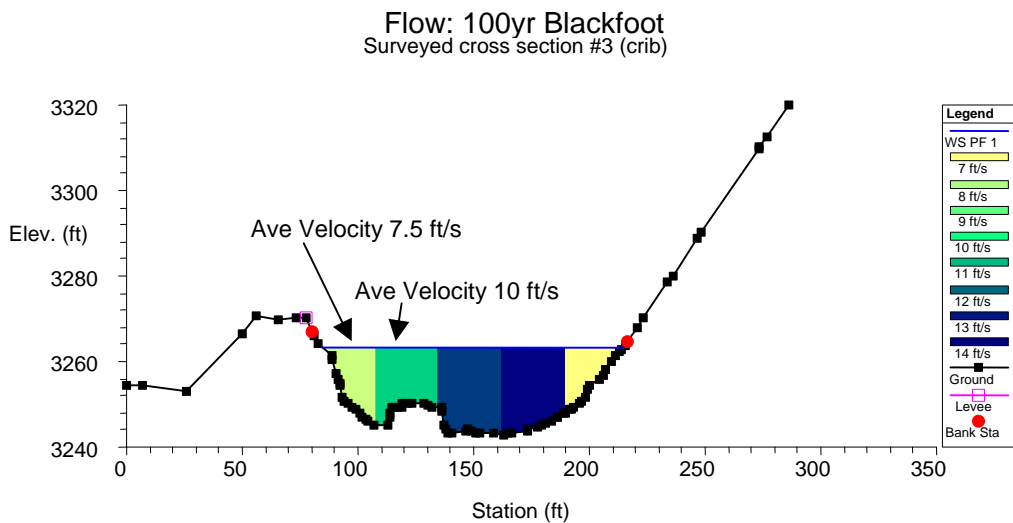
Figure 8. Velocity Distribution for 100 yr flow on Blackfoot at Cross section #3. Velocities in excess of 6 ft/s can be transport sediment.

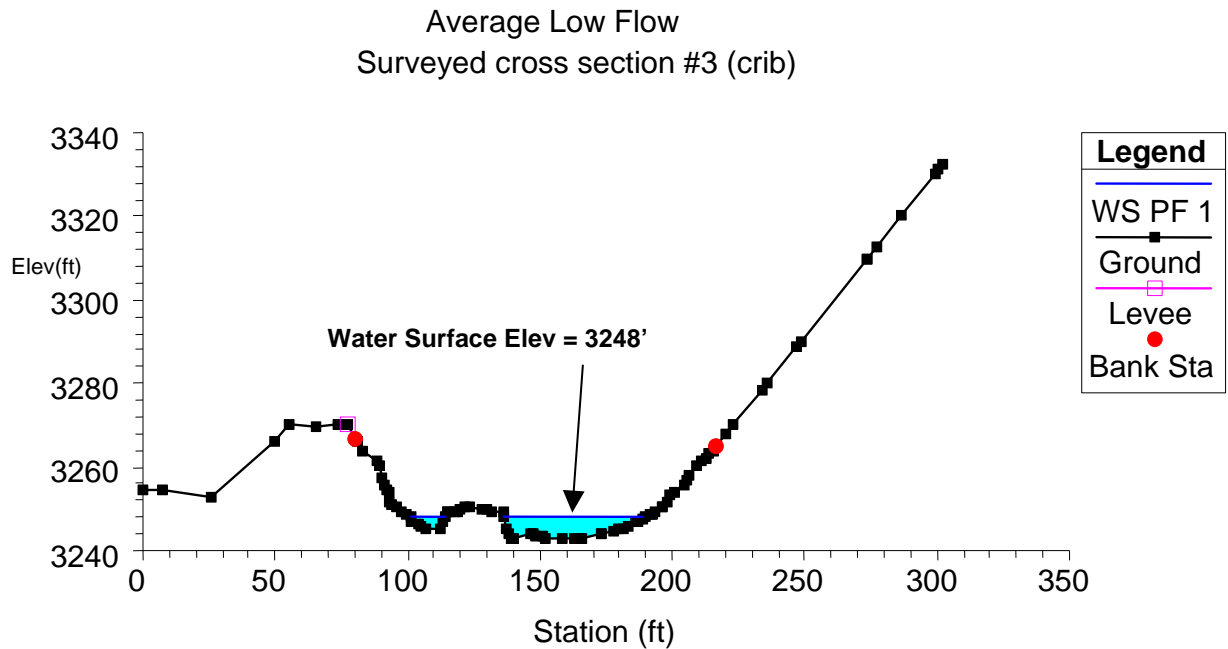
Figure 9. Water surface elevation for average low flow at cross section 3

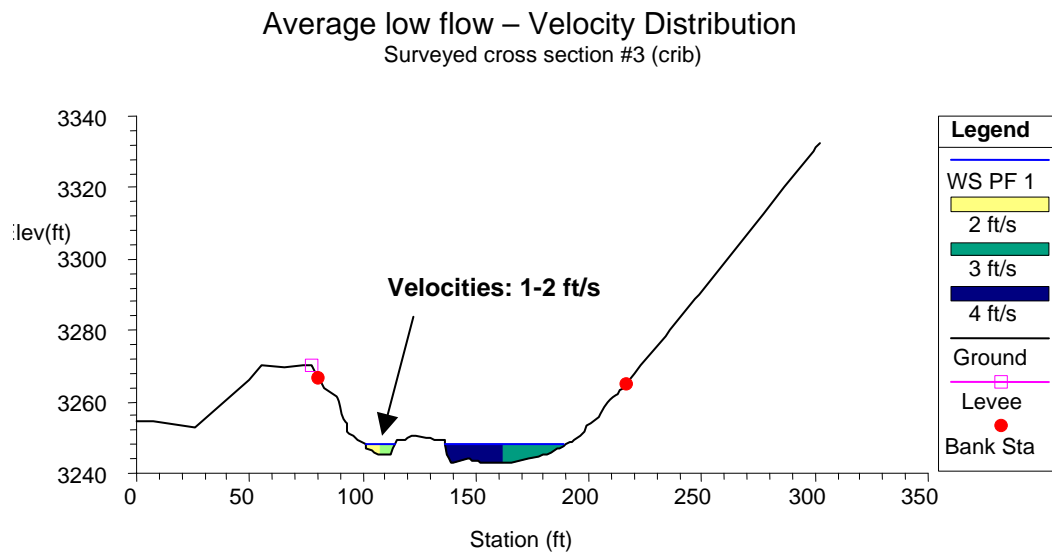
Figure 10. Velocity distribution for average low flow at cross section 3. Velocities are too low to cause significant scour and transport of sediments.

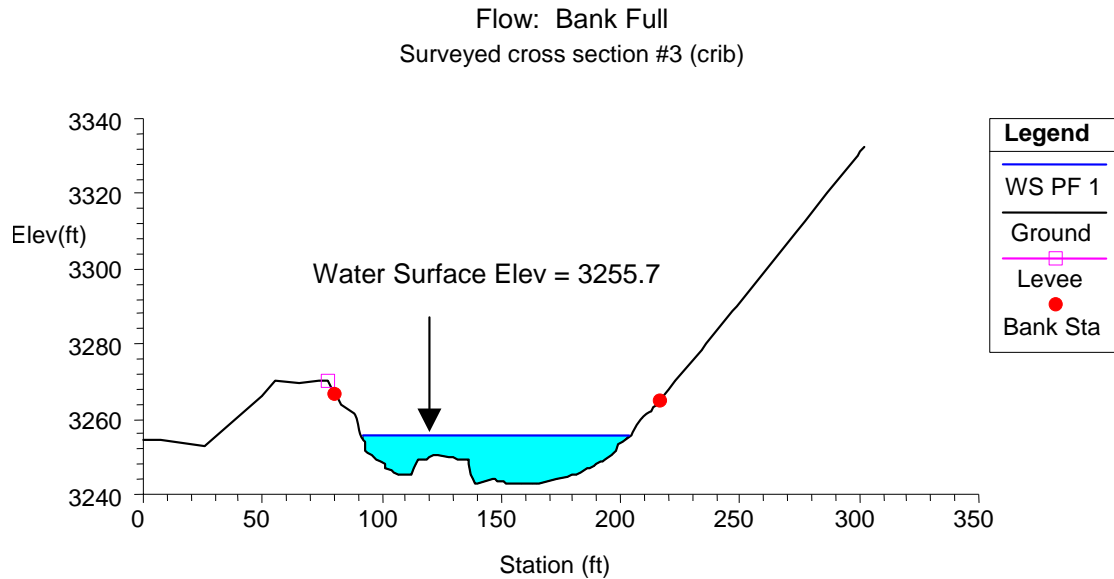
Figure 11. Water surface profile for bank full flow at cross section 3. "Bank Stations" shown on model reflect bank full stations prior to removal of Mill town Dam.

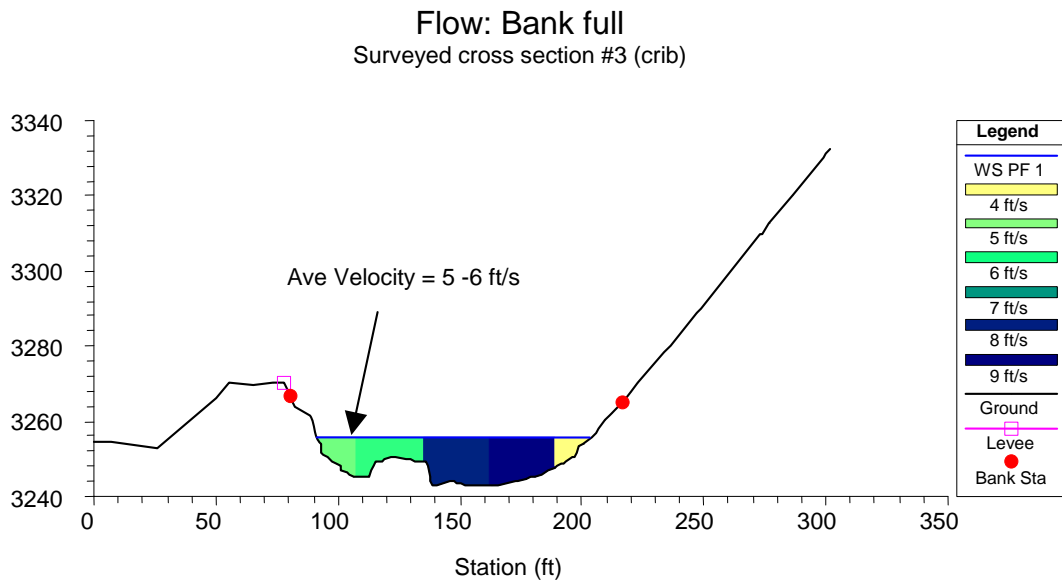
Figure 12. Velocity distribution at cross section #3 with bank full conditions. Scour and transport of sediments can initiate with velocities in this range

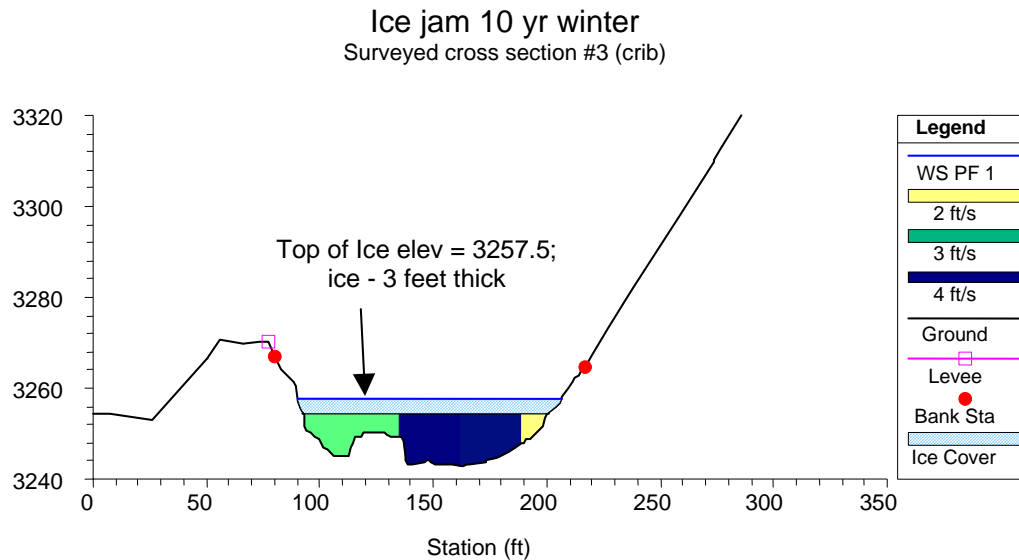
Figure 13. Water Surface and velocity distribution for 10-year winter flow event with ice jamming on Blackfoot River. Cooling pond embankment is not overtopped. Ice is gets up to 3 feet thick. Velocities remain low.

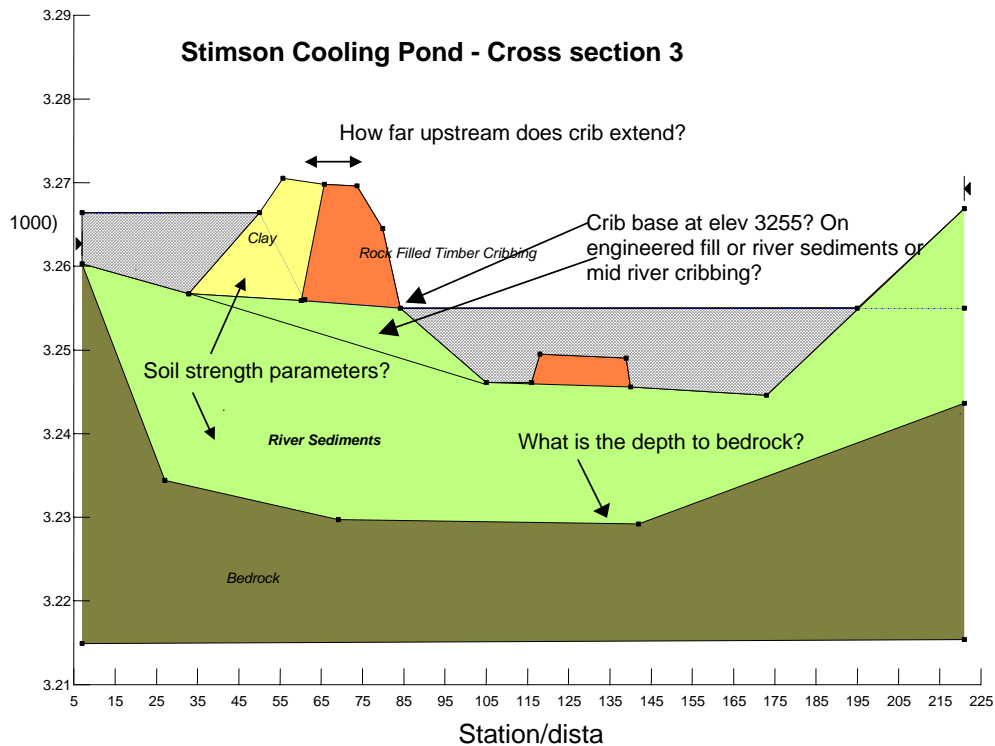
Figure 14. Conceptual model of cooling pond embankment at cross section #3 (timber crib area) highlighting the missing information necessary to adequately quantify stability.

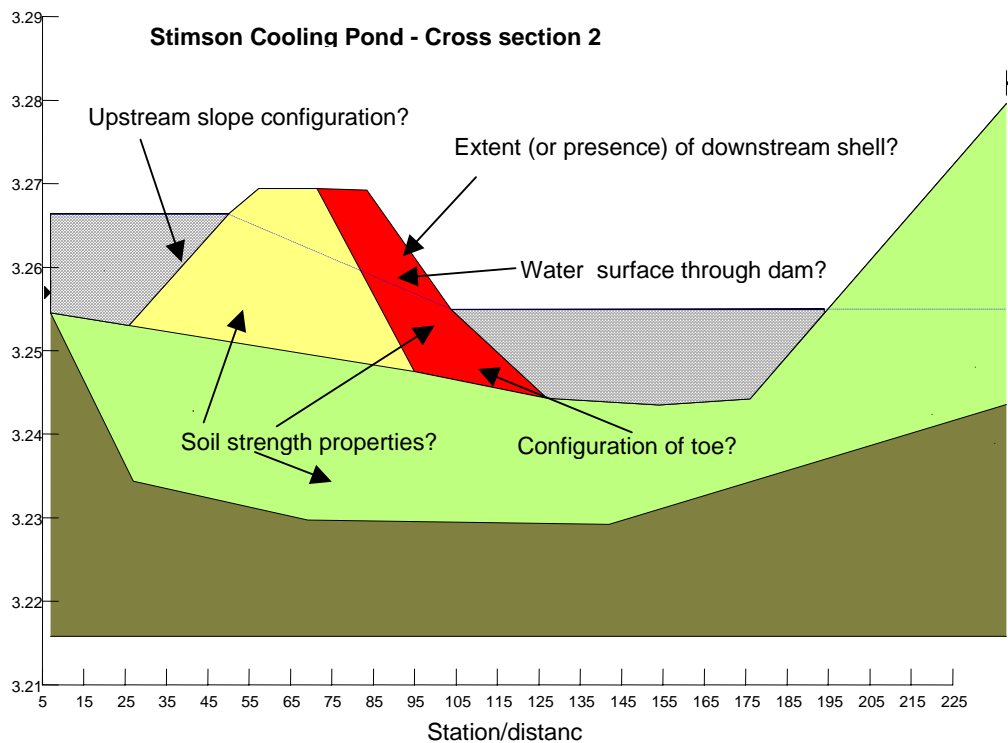
Figure 15. Conceptual model of cooling pond embankment at cross section #2 (soil embankment) highlighting the missing information necessary to adequately quantify stability

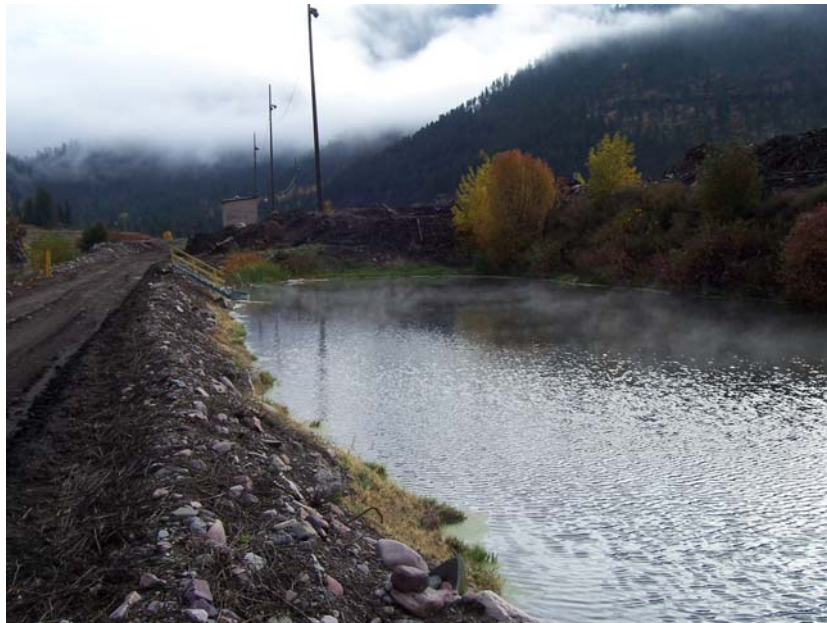
1. The base of the timber cribbing in locations where the mid river cribs are suspected to be absent appeared to be at elevation 3255 ft.
2. During our site visit in October, the Blackfoot River was drawn down to elevation 3255 ft. The pond remained at a virtually constant level. Therefore, it is reasonable to assume the upstream section of the embankments consists of low permeable clay soils, which is consistent with surface soil samples obtained at the site. Figure 16 shows the upstream face of the dam in the area of cross section 3. The upstream face appears to be gently sloping clay soils

Figure 16. Upstream face of embankment in area of cross section #3. Note gentle slope.

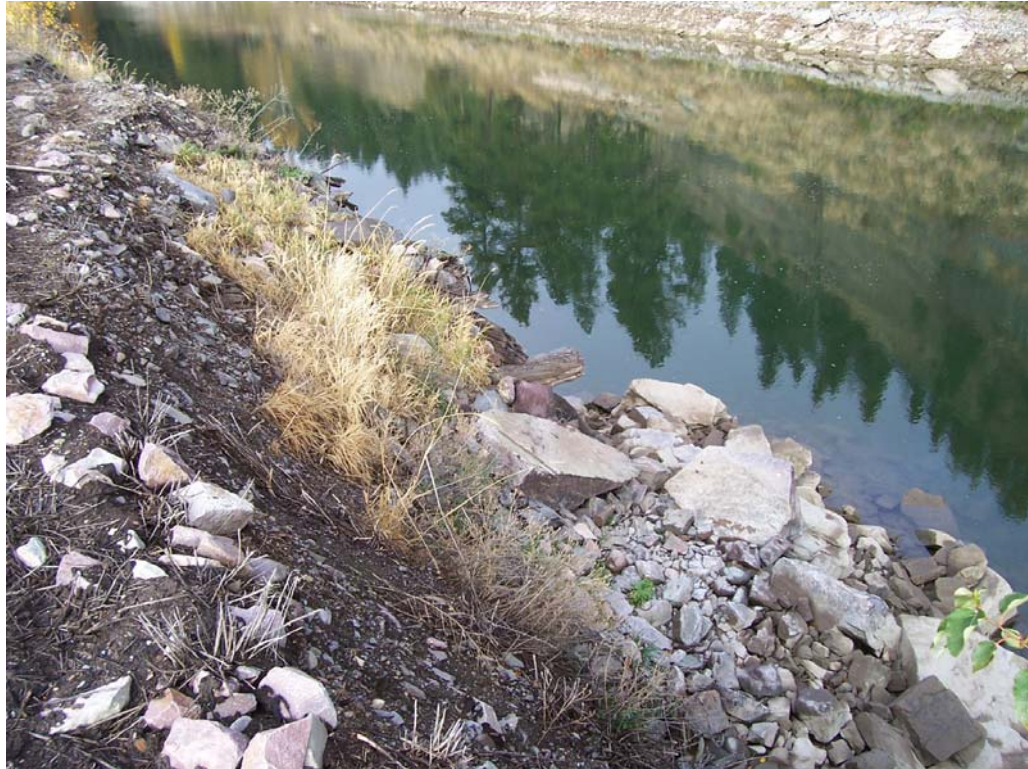
3. The downstream face of the dam was unsaturated, and showed no evidence of seepage. Therefore, it is reasonable to assume the downstream section of the embankment and cribbing is very free draining. Most likely the cribbing is rock filled, and the embankment has a gravel rock shell. Figure 17 shows the downstream face of the dam in the area of cross section #2

Figure 17. Downstream “shell” of soil embankment in area of cross-section #2

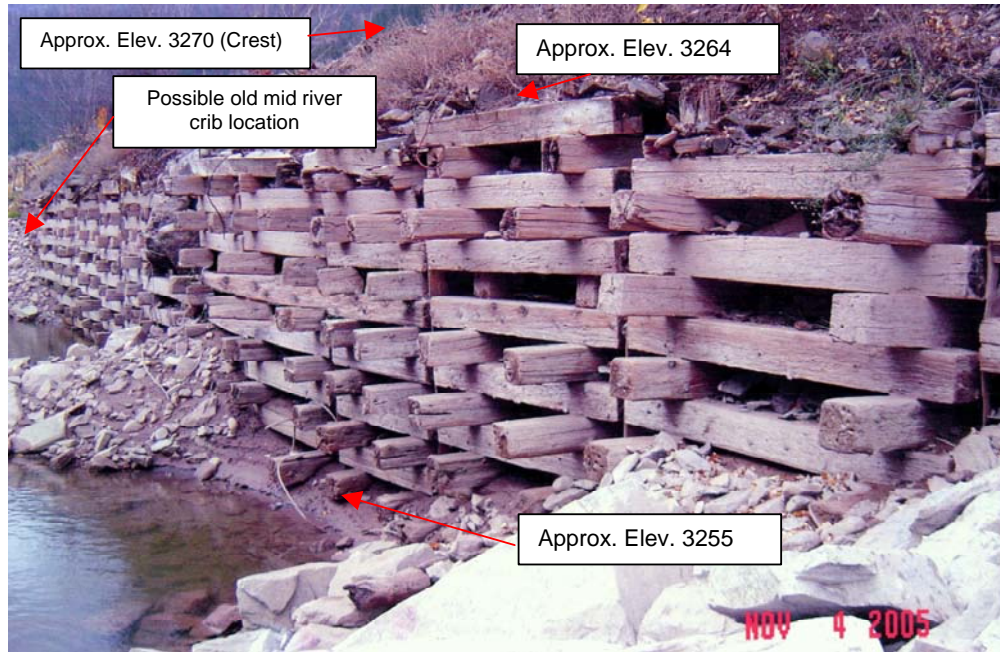
7. There was evidence of deterioration of timber crib that has been above or right at Blackfoot River water levels with Milltown dam in place (Figure 18). It is reasonable to assume that timber cribbing that will newly be exposed will rapidly deteriorate.

Figure 6: Timber crib section of cooling pond. With Milltown dam in place, the water surface elevation of the Blackfoot River is at elevation 3262 ft. In this photo, water was drawn down for removal of the Stimson dam.

1. The embankment should be removed and relocated for the following reasons:
 - a. There is strong potential for undercutting of timber crib at bankfull conditions; there is also strong potential for erosion of the toe.
 - b. There is potential for ice damage to the timber crib, that wasn't present in the past.
 - c. The timber cribbing is expected to dramatically deteriorate in the next five years, presenting stability problems
 - d. The embankment may not meet required safety factors
